CASE STUDY

- 11 kV Switchgear
- Mining Industry
- Asset Management
- Failure Prevention

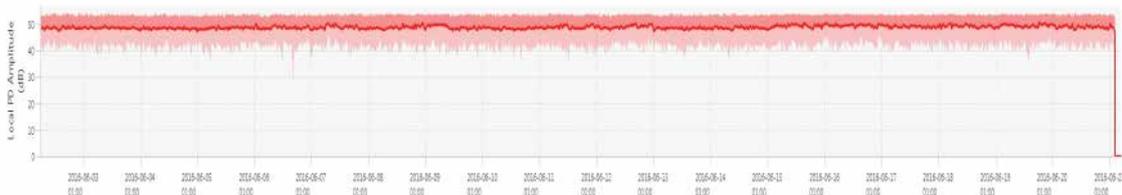
Asset	Sensor Type	Cable PD Peak (nC)	Cable OLPD Activity (nC/cycle)	Local PD (dB)	Local OLPD cctivity (mV/cycle)	Condition / Comments
Back Panel 2	HFCT	1.17	11.81	49	744	Major concern, locate PD and then repair or replace

Continuous OLPD Monitoring Data from 11 kV Air Insulated Switchgear Panel 2 over 19 days – high and continuous partial discharge

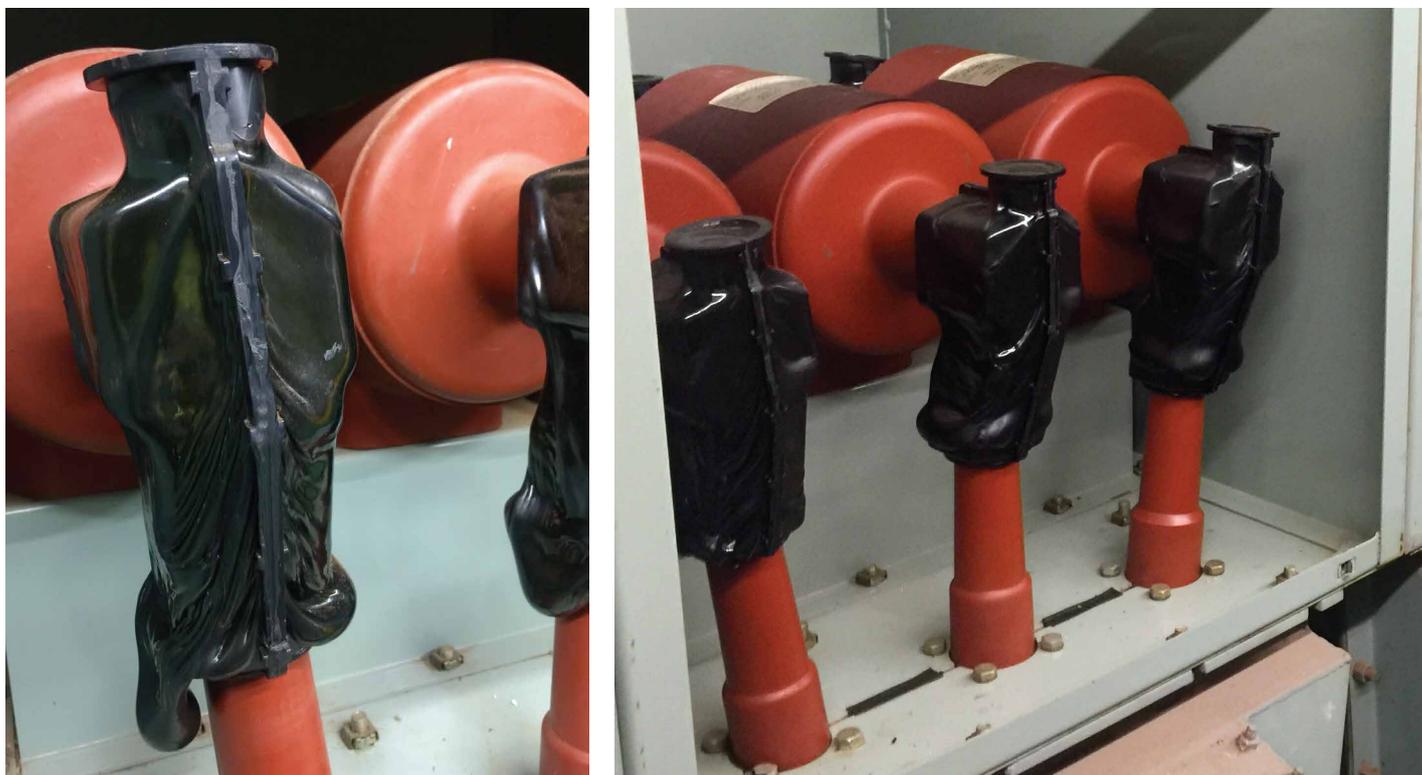
An outage of the switchboard was arranged to carry out a visual inspection of the 11 kV cable box and CT chamber and to carry out any repairs necessary. The visual inspection showed **significant insulation degradation issues with the cast epoxy resin 'riser' and synthetic resin-bonded-paper (SRBP) bushings** on all phases in the CT chamber in 11 kV switchgear Panel 2.

Source of High PD Activity: Deteriorated Insulation of the Cast Epoxy Resin Riser

- A visual inspection of the CT chamber confirmed a significant deterioration of insulation on the epoxy risers all phases of Panel 2 with both partial discharge and thermal runaway identified.

- HVPD strongly recommend that any repaired HV plant is re-tested after being put back into a service, in order to confirm the effectiveness of the repairs made i.e. they are 'PD-free'.
