USER MANUAL

The PDSurveyor™

Universal, Hand-held On-line Partial Discharge (PD) Surveying Tool for Insulation Condition Testing of 3.3 kV to 45 kV Cables and Plant

PDSurveyor™ User Manual

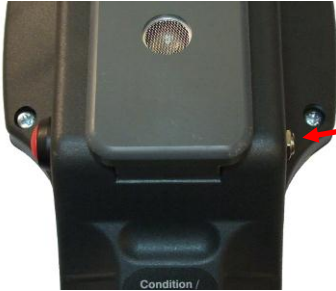
Charger Connection

Before first use, the PDSurveyor™ should be charged for at least 2 hours with the supplied charger. With normal use, the device should be fully charged at least once every week. The power LED flashing indicates a low battery.

Note: Only use the supplied battery charger.

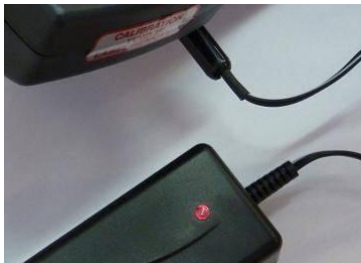
PDSurveyor™ Charging

When the battery charger is connected to a mains supply and the PDSurveyor™, its LED will change colour as follows:

Red: Charging
Green: Charged

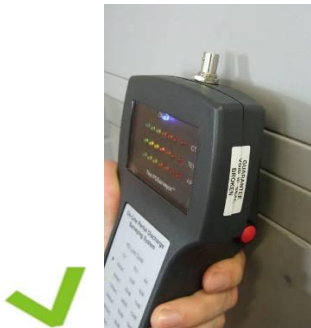
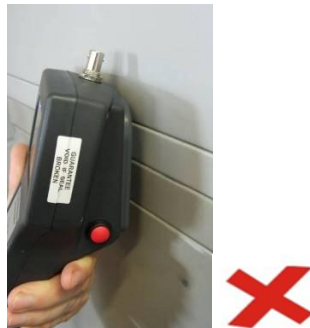
The TEV sensor should be placed flat against the metal-clad switchgear close to vents or gaskets or seams on the metal-clad housing. The LEDs will light to show the measured PD level. The user **MUST** hold the unit whilst in use.

It is recommended to place the TEV sensor at multiple points on the plant for example on the cable boxes and front and back of each switchgear panel.

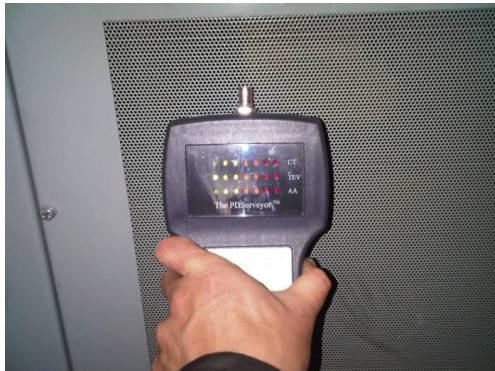
The sensor should be placed over vents or air gaps in the switchgear housing as shown below. The LEDs will light to show the measured PD level.

As the acoustic sensor has a limited +/- 30° angle 'field of detection' it is possible, by moving the direction of the unit slightly, to locate the source of the air discharge, see Example 2, Appendix 2.

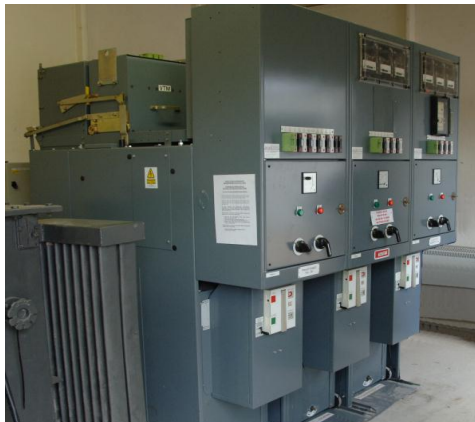
The purpose of the testing was to evaluate the condition of the 3x 11 kV GEC VMX switchgear panels. This type of switchgear has a history of PD problems, mainly associated with the VT and the cast resin parts of the circuit breaker spouts. The PD activity detected has been associated with discharges in air and surface tracking (in contrast with internal) PD activity in voids in the insulation. The PD activity in air can lead to long term damage to the insulating surfaces of the switchgear, and this damage can result in reduced hydrophobicity of the insulating surfaces. In this condition, tracking and discharge related erosion are then both possible which can then lead to failure in service, which is why this type of switchgear must be kept free of PD activity.

Figure 4: Front View of GEC VMX AIS Panels No.1, No.2 & No.3 (from left to right)

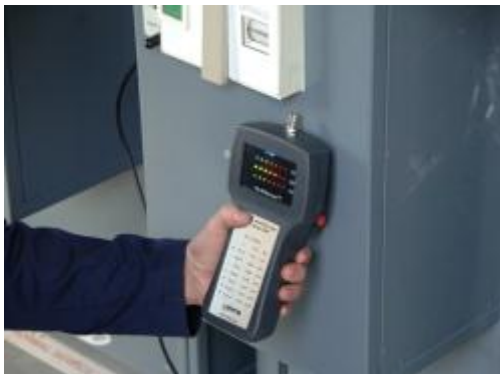
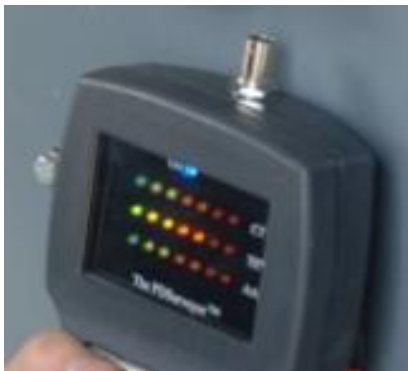
Figure 6: Panel 2 – PDSurveyor™ Display (RED 1 Level = 44 dB)

Test 2: PD Screening (TEV and AA Sensors) of 11 kV GEC VMX AIS – *Panel No.2*
The same test was repeated on the front of Panel 2. PD levels were detected with 6 LEDs (RED 1) which equates to 44 dB of TEV partial discharge which is a *very high level for this type of switchgear*. Further testing at the sides and back of the housing showed an intermittent LED (GREEN 1) as per Test 1 (low level of PD).

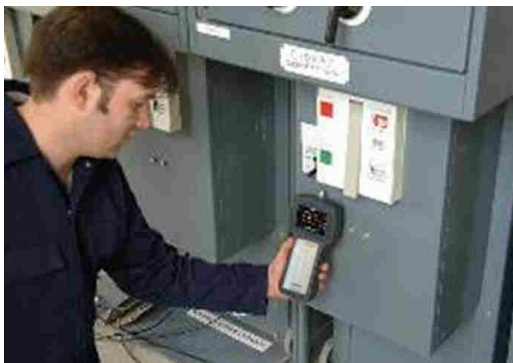
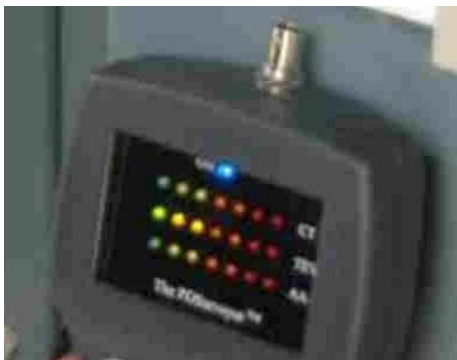
Figure 7: Panel 3 – PDSurveyor™ Display (YELLOW 2 Level = 28 dB)

Test 3: PD Screening (TEV and AA Sensors) of 11 kV GEC VMX AIS – 3rd Panel
The same test was repeated on the front of Panel 3. The result of the test was the same as per the test on Panel 1 i.e. a level of **3 LEDs (YELLOW 2)**, equating to **28 dB** of partial discharge. Further testing at the sides and back of the housing showed an intermittent LED (GREEN 1) as per Tests 1 and 2.

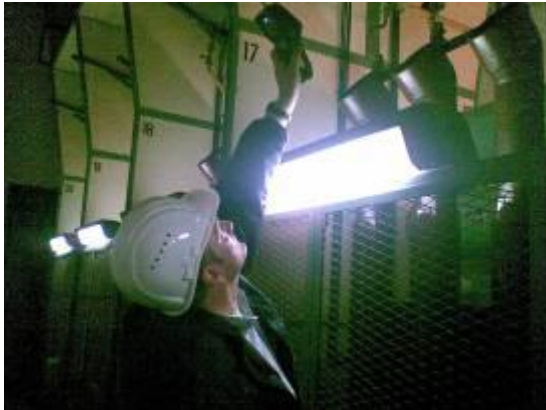
A quick survey (<1 minute per bay) was carried out of all bays of open-frame, AIS switchgear on the three 30 kV bus sections at the substation. The survey utilised the PDSurveyor Airborne Acoustic (AA) sensor shown in operation in Figure 8.

Figure 8: Survey of Air Insulated Switchgear with the PDSurveyor™ Airborne Acoustic Sensor

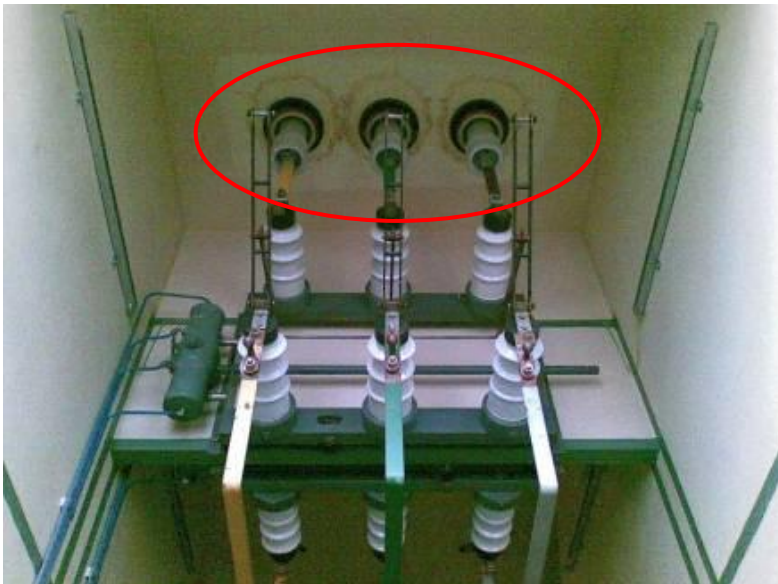
Only bay 2 showed acoustic PD activity, which showed 20 dB originating on the bushing. On closer inspection of the cable termination and bushings, water damage was visible on the ceiling, as shown in Figure 9. It is highly likely that this is the source of the discharge activity detected using the PDSurveyor™.

Figure 9: Water Damage on T42 30 kV Bay 2 Bushings

the advice to the plant owner here was to re-test this switchgear regularly (at a minimum of every 3 – months) and to also consider the monitoring of the PD activity over an extended period of time to check that the levels of PD activity do not increase.

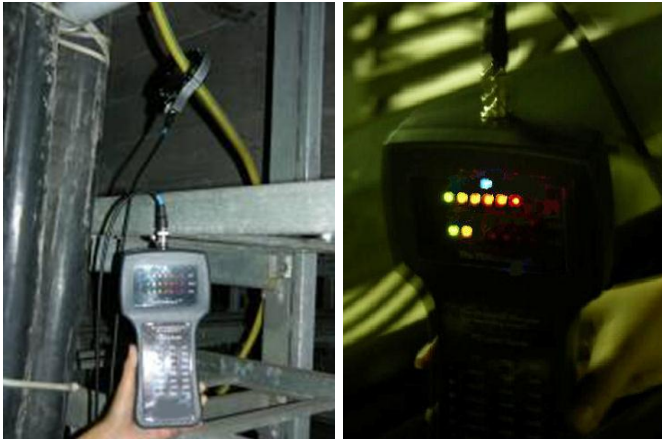
The 150 metre long cables supplying the MV motors in the factory were connected at the main substation by earth straps to a common earth bar. PD Screening tests were made at the main substation end of the cable with the HFCT sensor clipped around the individual earth straps of each of the cables in turn to measure the PD levels on the cables. The PDSurveyor™ results showed very high ‘Cable’ PD levels of up to 6 LEDs (RED 1- 20,000 pC+) on the *N2 Compressor Motor Cable* (see Figure 10 below). PD levels of up to 3,300 pC+ and were also detected on the earth straps of the cable feeders on each side of the N2 Compressor Motor Feeder which shared the common earth bar.

Figure 10: PDSurveyor™ with HFCT on earth strap of N2 Motor Compressor Cable showing 6x LEDs (RED 1 lit) on HFCT (20,000 pC)

It appeared from the survey that *the source of the PD was from the N2 Compressor Motor cable feeder* as this showed the highest levels of PD (at 20,000 pC+) compared to its nearest 2x cables (to the Transformer and the Air Compressor at 9,000 pC and 3300 pC+ respectively). The next stage of the investigation was to carry out Diagnostic Testing with the HVPD Longshot™ PD Spot Tester and Monitor to further confirm and then locate the source of the very high PD pulses.

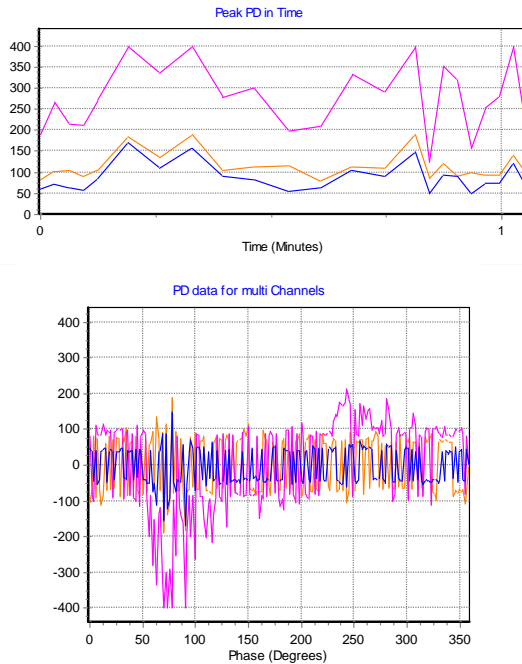
- Ch 1 – Orange Colour – Transformer Cable
- Ch 2 – Pink Colour – N2 Compressor Motor Cable
- Ch 3 – Blue Colour – Air Compressor Motor Cable

Figure 11: PD Test Data across 50Hz Power Cycle – HFCTs attached to Earth Strap Ch 1 (Orange) – Cable to Transformer, Ch 2 – N2 Compressor, Ch3 – Air Compressor

The PDGold© Event Recogniser Software with ‘Event Recogniser’ module was used to carry out further Diagnostic Analysis of the HVPD Longshot™ PD Data shown above in Figure 11. Some of the results from this analysis are shown below in Figure 12.

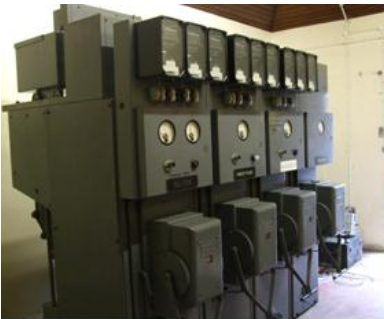
<p>Secondary Substation</p>	PDSurveyor™ Results		
	Panel	Name	TEV PD Level
	1	Transformer	● ● ● ●
	2	Balhousesie St	● ● ● ●
	3	Harley Place	● ● ● ● ●
4	McDonalds	● ● ● ● ● ● ●

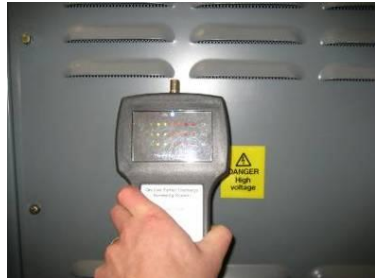
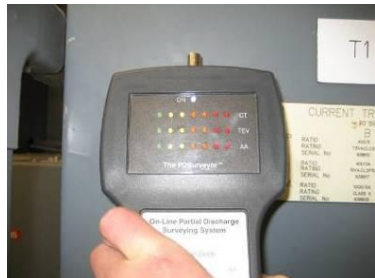
High TEV readings were measured across the switchgear, and were highest close to TR2 VT

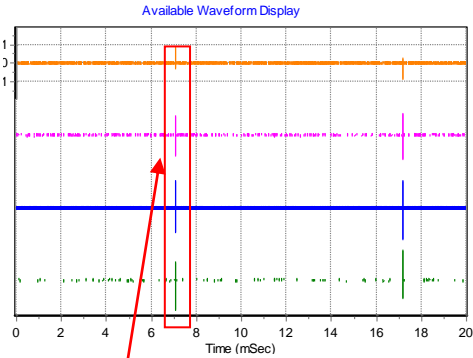
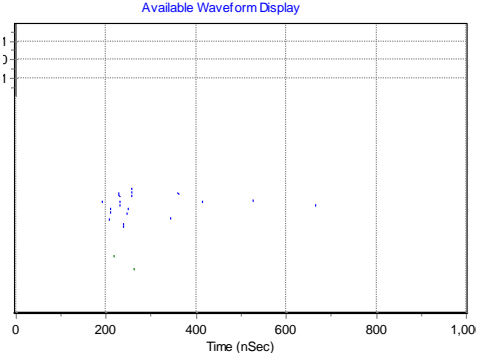
20 ms Power Cycle

PD Event Over 20 ns

PD Event

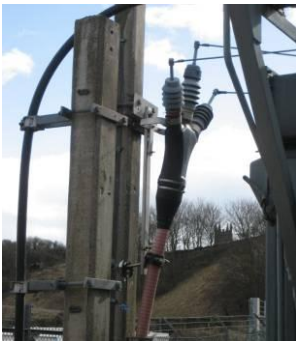
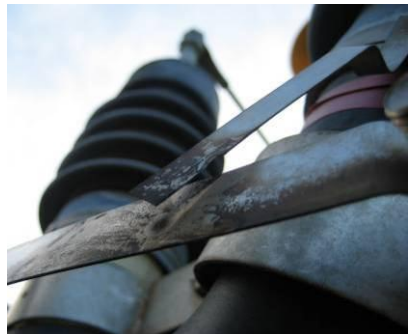
Visual inspection of outdoor termination found floating metalwork at the cable termination – and a satisfactory temporary repair was emplaced until permanent repair performed.

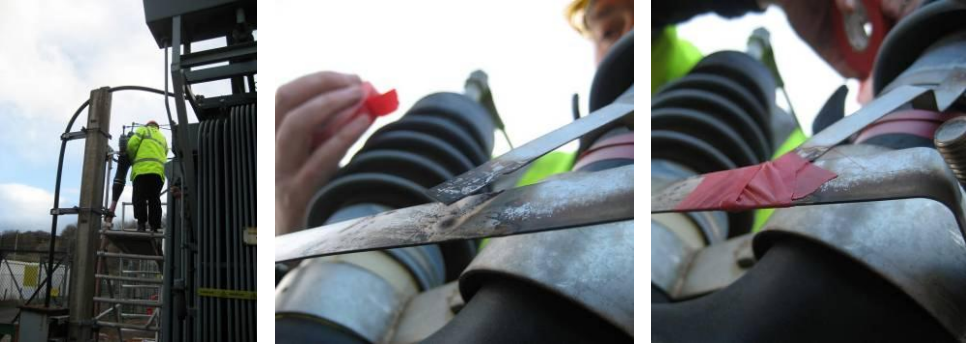
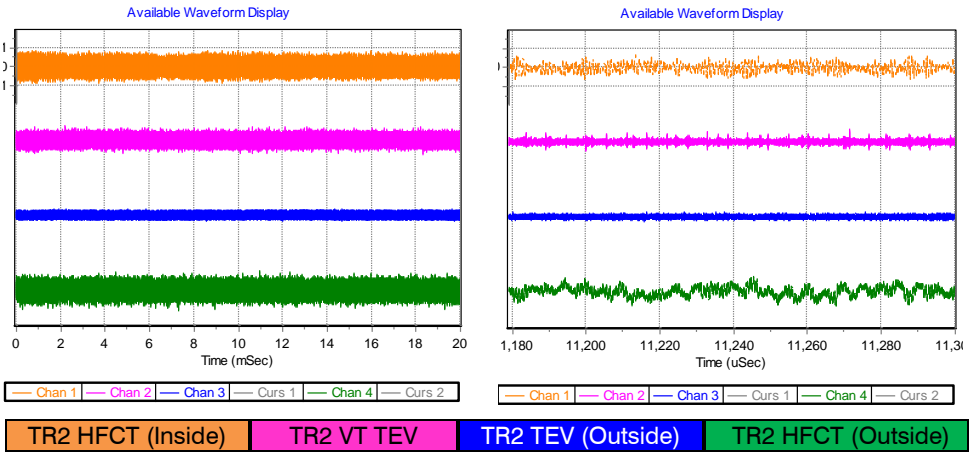
No detectable PD was observed after the loose metalwork was reattached.

After rectification, the PDSurveyor™ results were all significantly reduced, and no PD was observed above the local low-level background noise.

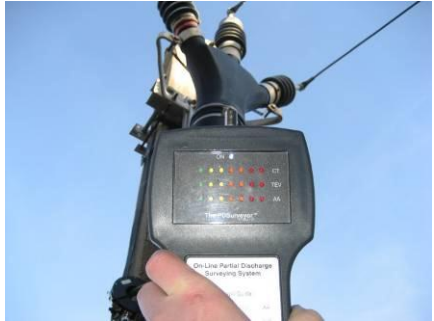
No Corona activity detected acoustically

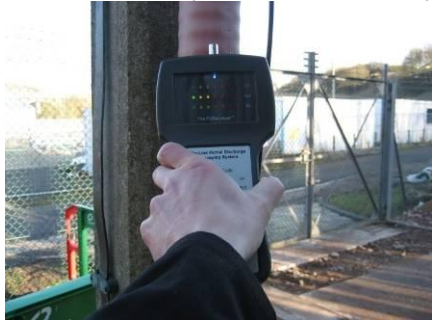
Low-Moderate TEV Activity as a result of Corona activity at termination

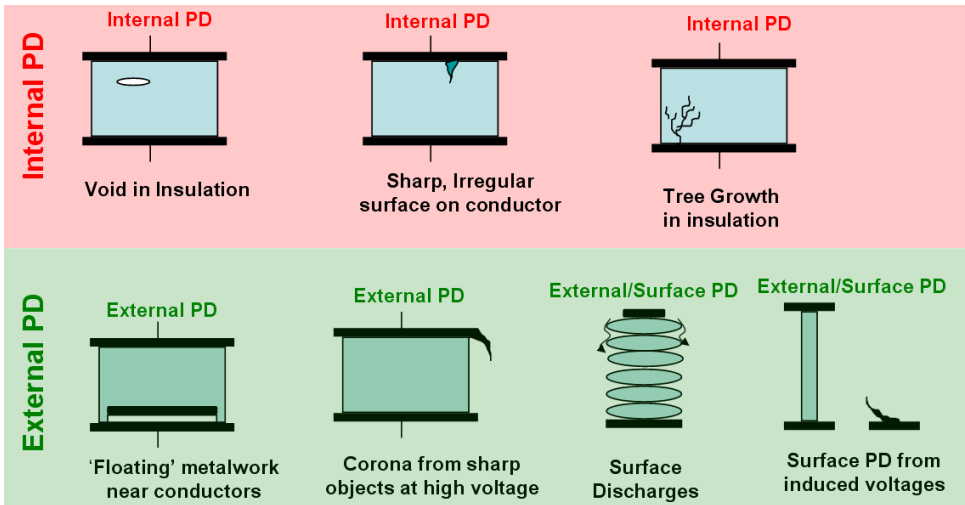
IEEE statistics indicate electrical insulation deterioration by age or thermal stressing causes up to 90% of electrical failures of certain high voltage equipment, caused by improper installation or design. Unlike off-line testing, on-line PD testing and monitoring gives an accurate picture of the plant’s health and performance under service conditions. It is known that some discharges can be extremely dangerous to the health of the insulation system, and determining this accurately is a key reason why many industrial and utility operators perform regular PD testing. Dangerous PD includes internal discharges within polymeric cables and accessories or surface tracking in air-insulated switchgear). Other types can be relatively benign (e.g. corona into air from HV conductors and surface discharges on outdoor porcelain insulators). The various types of PD activity are shown in Figure 14 (below).

Figure 14: The Seven Main Types of PD Activity (inc. internal and external PD)
