# HVPD Mini™ Monitor Case Study Online Partial Discharge Monitoring Of Medium Voltage Switchgear

**4-Channel Portable Online Partial Discharge Monitor**  
*Continuous, Remote Access Insulation Condition Monitoring  
of 3.3 kV – 45 kV Cables & Switchgear*

## Case Study – Continuous On-line PD Monitoring of MV Switchgear

## Plant Monitored: 11 kV GEC/Alstom VMX Air-Insulated Switchgear

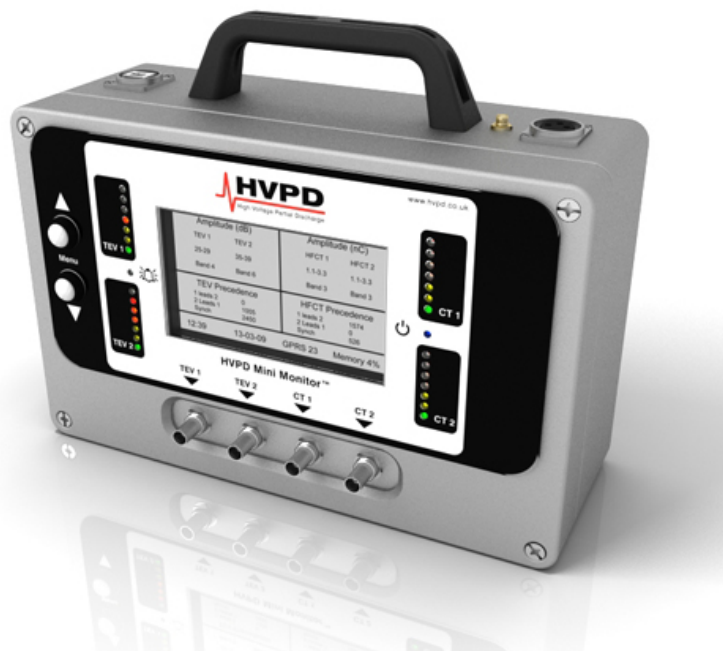
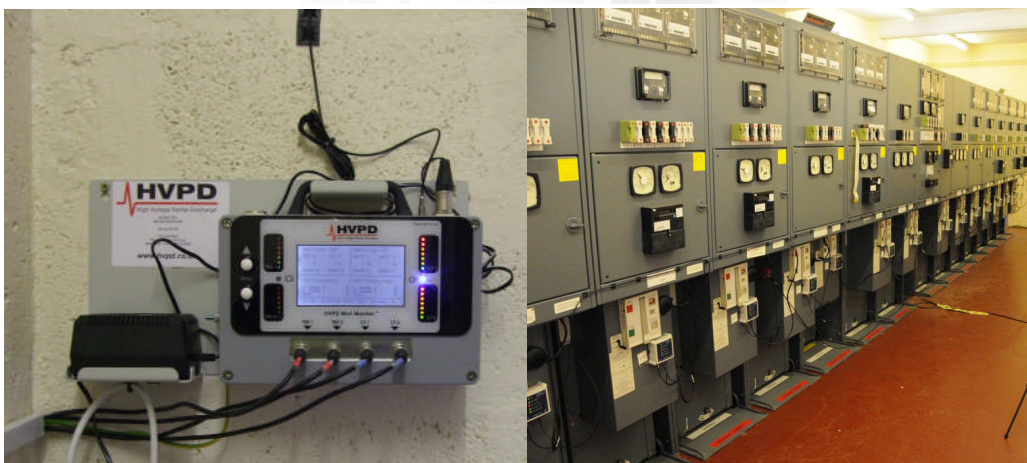
An instantaneous display of the peak PD level is given for each of the 4 channels of the unit via colour-coded 7-level LED arrays. The unit's LCD display shows the peak level and signal 'precedence' for the past 24 hour period. The logged data is stored locally on the unit's inbuilt flash memory for either local download (through a USB connection to a laptop PC) or remote upload of data to a remote FTP server with the inbuilt GPRS modem. Data can be viewed on a PC with the HVPD MiniReader® software for Microsoft® Windows®.

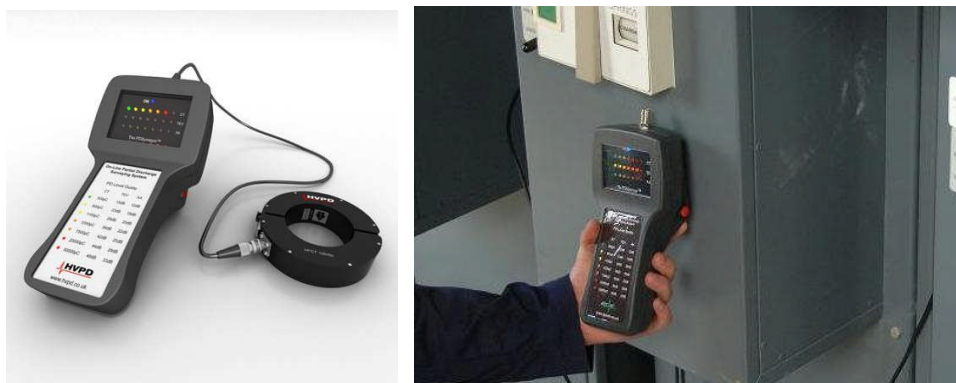
**Figure 2: The HVPD PDSurveyor™ - TEV PD Detection on Cable Terminations and Switchgear**

High levels of PD activity were initially detected on the customer's 11 kV GEC VMX Switchgear in the Grid Primary 132 kV / 11 kV substation using the Transient Earth Voltage (TEV) sensor within the handheld PDSurveyor™ system (Figure 2) during a routine walk-by inspection. This PD activity was found to be intermittent in nature.

The PDSurveyor™ allows for very rapid *walk-by PD* screening of both MV switchgear and cables with a 'typical' 16-feeder primary indoor substation requiring around 20 minutes to complete a 'look-see' PD survey. This testing takes around 1 minute per panel and cable circuit to check the PD levels of the cables and switchgear with most of the time taken up attaching and removing the HFCT sensors between circuits.

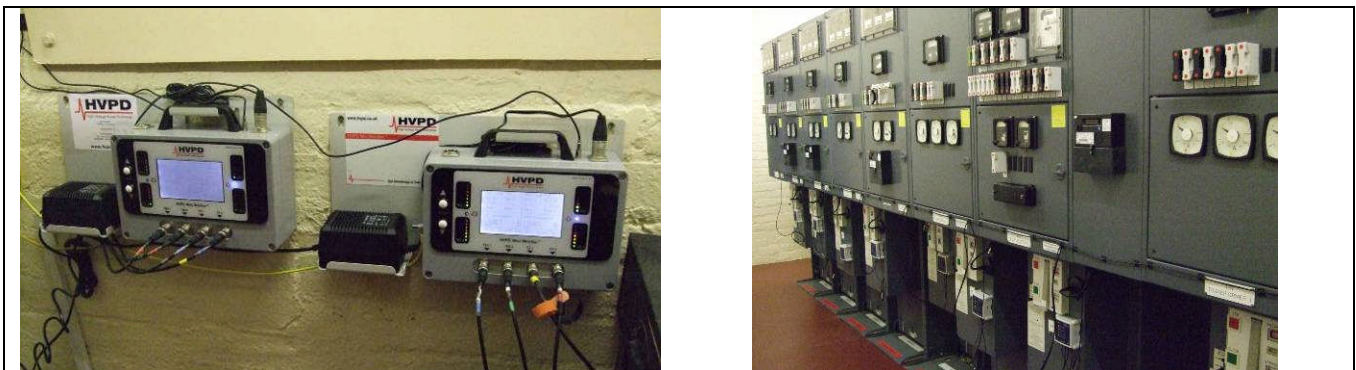
HVPD Mini™ Monitors Installed At Site

VMX 11 kV Switchgear

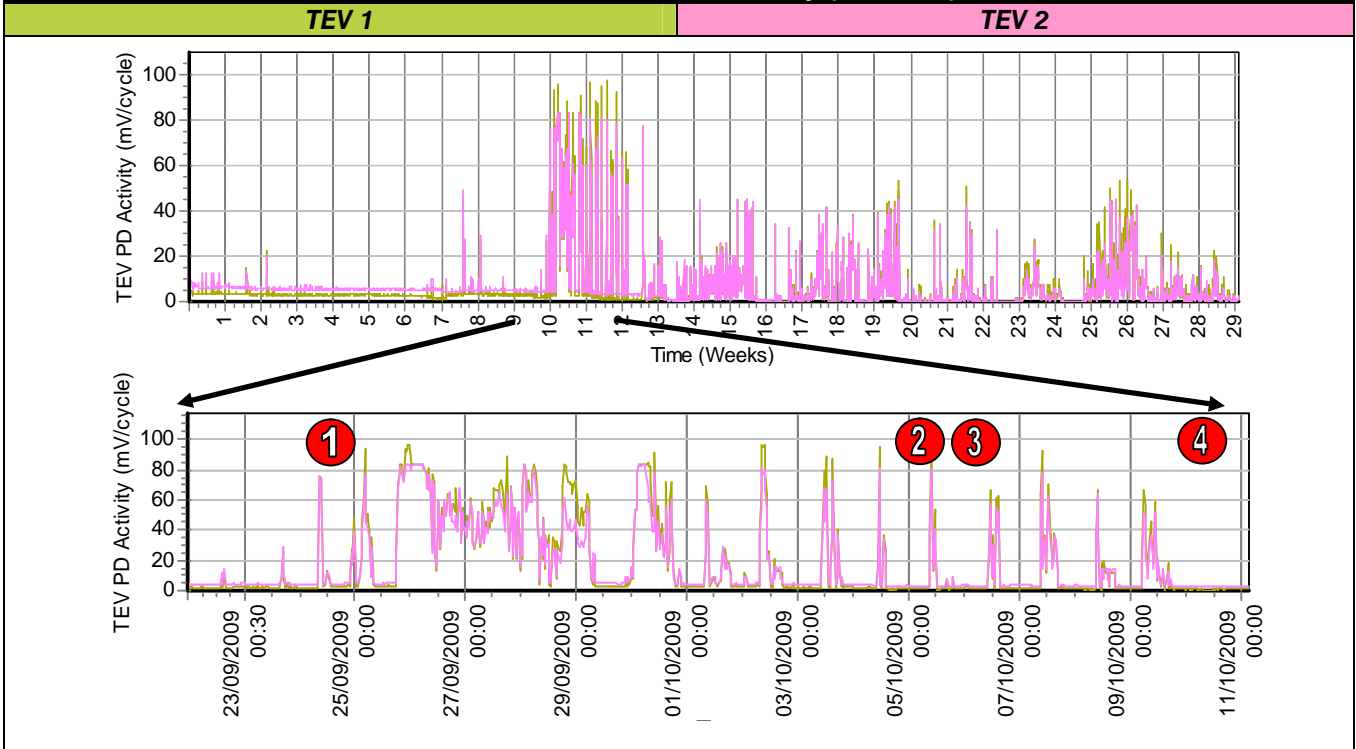
HVPD Mini™ Monitor TEV Activity (Local PD)

Precedence Counts TEV Sensors

- 1) Large rise in TEV activity in week 10 (25<sup>th</sup> Sept 09) with sustained high level of TEV PD activity of 80 mV/cycle and above for 1 week also corresponding with significant increase in Precedence Counts which indicate TEV1 (Transformer 1 Panel) as the PD source
- 2) Audible PD heard on visit to the substation by Customer's Engineer (5<sup>th</sup> Oct 09)
- 3) Circuit breaker switched off and truck taken out of service for cleaning (6<sup>th</sup> Oct 09)
- 4) Period of calm during week 12 (10<sup>th</sup> Oct 09) after maintenance with a significant reduction in Precedence Counts – However there remains at least one other PD source still present on the switchboard in the direction of TEV 1.

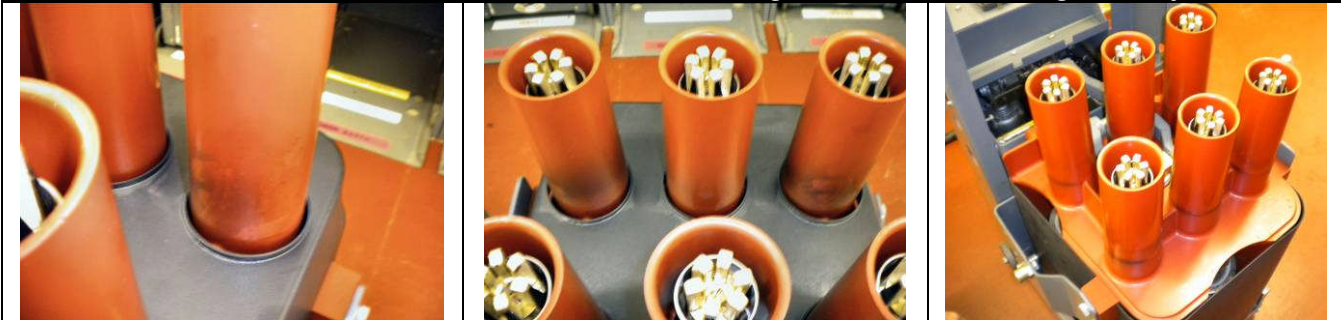
**Circuit Breaker Truck Removed From Service - Signs of Surface Discharge Activity Evident**

This circuit breaker truck was removed from service due to the early warning provided by the HVPD Mini Monitor and then the audible PD activity being heard on site by maintenance engineers during investigation. The photos above show clear signs of the onset of surface PD activity (black deposits) which are present on the lower portion of the switchgear 'spouts'.

The High Levels of Local PD activity were located to the Circuit Breaker Truck of 'Transformer 1'. The 'spouts' of the truck were cleaned with a suitable solvent and the breaker put back into service.

*The evidence of the photographs of the truck and the audible discharges which were heard by the Customer's Engineer on 9<sup>th</sup> Oct 2009 suggests the early stages of surface discharges are occurring on the 'spouts' on this circuit breaker truck. However, as there is presently no sign of any surface tracking on the spouts it can be ascertained that the switchgear is not in danger of imminent failure.*

### **Action - it was recommended that the switchgear truck's 'spouts' were cleaned with a suitable solvent & inspected before being put back into service.**

*Since this maintenance action was carried out, the PD activity levels measured by the HVPD Mini™ Monitor units have dropped to between 20-40 mV/cycle which is significantly lower than the levels of 80-100 mV which were detected over the 2 week period between the 24<sup>th</sup> September and 9<sup>th</sup> October 2009. As the PD activity today is less than it was in this 2 week period, it can be argued that the switchgear is under less of a risk of failure than it was. However, this situation can change, as happened on the 24<sup>th</sup> September 2009, and it is thus advised that the PD activity in this substation is continuously monitored into the future to ensure PD levels do not rise again.*
