PARTIAL DISCHARGE MEASUREMENTS AND DAMAGE TO HIGH VOLTAGE CABLES.

R.R. Mackinlay*, M. Michel † Lee Renforth †
*High Voltage Solutions Ltd, †EdF Energy
†Ipec Engineering

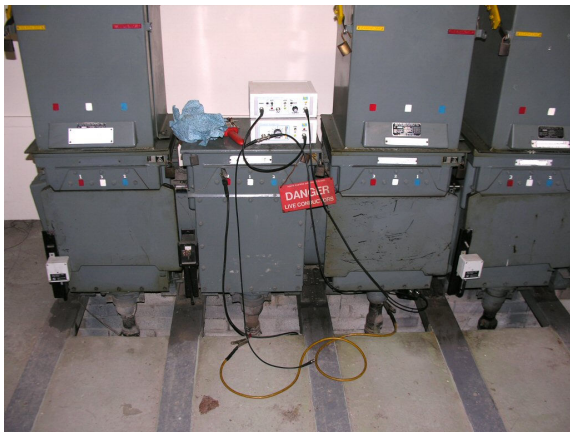
Figure 3 PD location equipment at the far end of the cable

Figure 3 shows the installation of the transponder equipment at the remote end of the circuit. The devices are battery operated and so can be used on those sites which have no local AC mains.

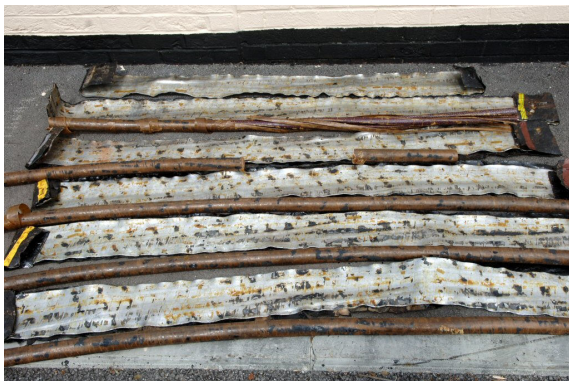
Figure 9 exposed core and lead sheath of around 10m of cable

Some 20m of recovered cable was taken to a jointing school and destructively examined. Figure 9 shows the lead opened and the cores laid adjacent to each other. The carbon caused by the PD activity can be clearly seen along almost the whole length of the recovered cable.

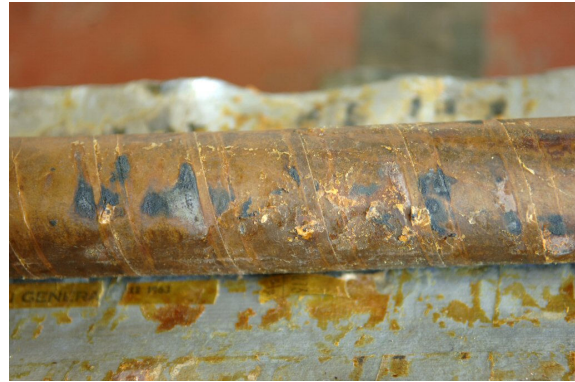
Figure 10 close up of outermost belt paper from PD site

A close up of the carbonized core is seen in figure 10. The PD damage is very extensive under the lead sheath.

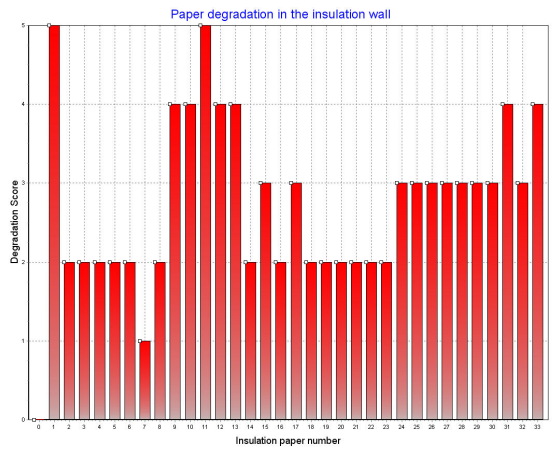
Figure 11 Degradation of the insulating papers in the core and belt. Papers 1 to 10 are in the belt, all others are in the core.

Figure 11 shows the degradation plot through the whole of the insulation wall. Core 1 was randomly chosen for this purpose, although clearly the two other cores would represent an equally valid cross section through the insulation. The first 10 papers are in the belt, and papers 11 to 33 are in the core.

The poor insulation quality at the outside of the core and the belt, do not continue all the way through the insulation. Whilst this cable is substantially deteriorated, it is certainly not in imminent danger of failure. Estimation of remaining life is very difficult, but failed cables have many papers with scores of 5 on this scale. This means that there may still be several years of service left in this cable before the degradation would result in failure in service. In this case it is debatable as to whether the cable would have been re-jointed. The wise engineer would probably have cut the cable back to clear the carbon from the belt.
