CASE STUDY

- 10 kV Ex/ATEX Motors
- Transport
- HFCT/TEV Sensors
- HVPD Longshot™

The transportation customer requested HVPD carried out On-line Partial Discharge (OLPD) testing on 33 kV cable joints. The testing was further to a number of recent faults within the customer's network, which led to disruption of the power supply to the light rail system.

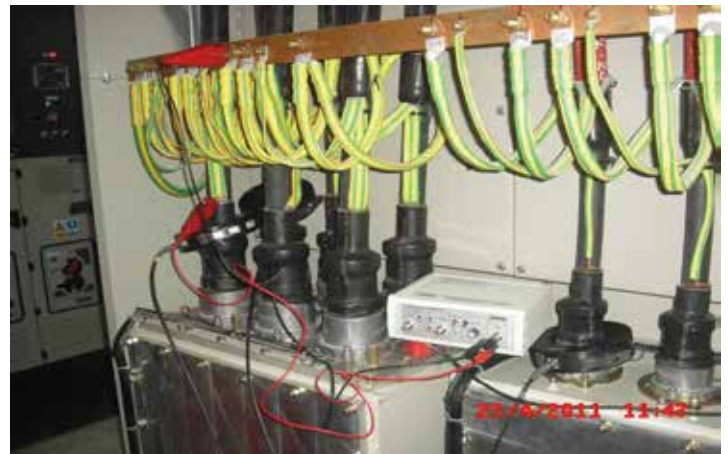
Testing on the 33 kV Cable Joints

Investigations started with calibration testing with pulse injection HFCTs, followed by OLPD measurements and then cable mapping tests.
